REF.	BUILDING	DATE	SURVEYOR
1	ANOTHER HOUSE	09/11/21	SURVEYOR

INTRODUCTION

EXTERNAL WALL INSULATION SYSTEM – MATERIAL BUILD-UP

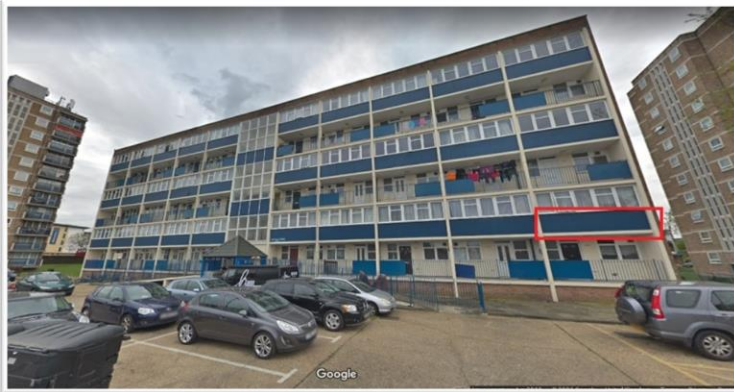
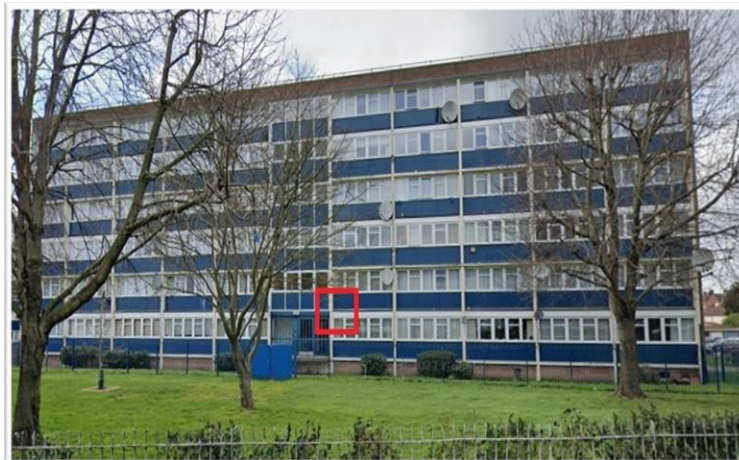
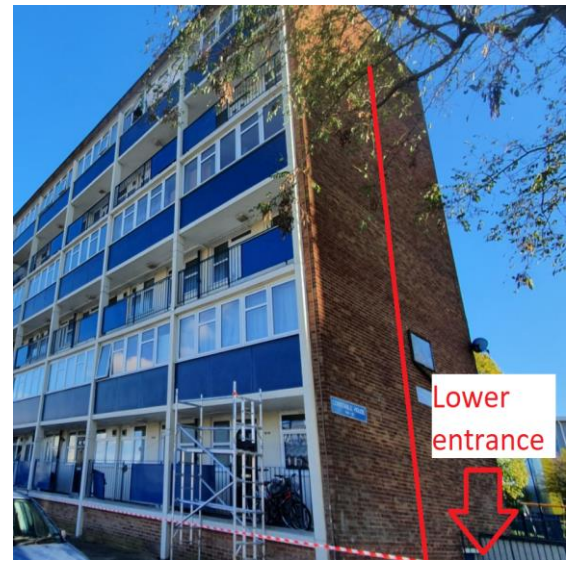
BUILDING ELEVATION / LOCATION OF INSPECTION | **BUILDING HEIGHT / STOREY**

Height = 6 storey building. Height using Disto x4 = 15.4 m
 + 2.1m = 17.5m
 This includes a 2.1m technical allowance for the lower storey entrance area (as per Approved Document B: regulation 7 (4)(b) measured from the lowest ground level adjoining the outside of a building to the top of the floor surface of the storey.)

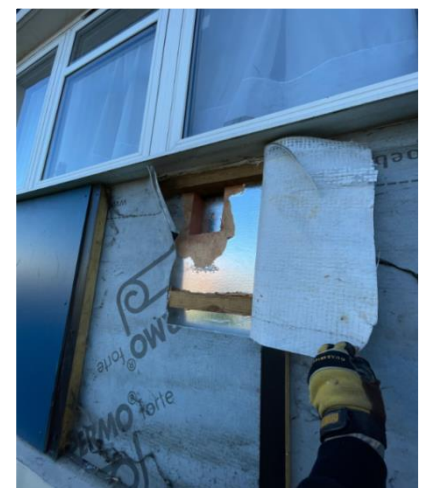
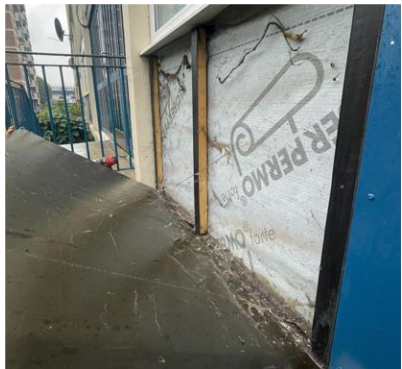
Location of inspection	To front and rear elevations at ground and first floors
System	Timber framework below aluminum windows with rigid insulation infill, inner plasterboard and outer Trespa HPL panel. Spandrel panel noted to kitchen window ventilation extract.
External cladding material & characteristics	Trespa Meteon HPL panel –8mm
External cladding combustibility	Non FR HPL panels are categorised as Euroclass B or lower* (See Appendix)
Insulation/Thickness	Phenolic foam board – 60mm
Insulation combustibility rating	Euroclass B or lower
Fixing Frame / backing wall material & characteristics	Timber studwork with internal plasterboard sheet lining assumed 12.5mm
Fixing Frame / backing wall combustibility	Timber framing backing wall is categorized as Euroclass B or lower
Fire barriers	<ul style="list-style-type: none"> • Floor slab / masonry separating wall act as nominal fire barriers between housing units. • Vertical cross wall solid masonry construction between housing units

Cladding system combustibility rating	Euroclass B or lower

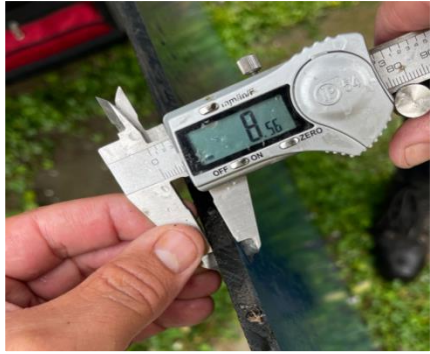
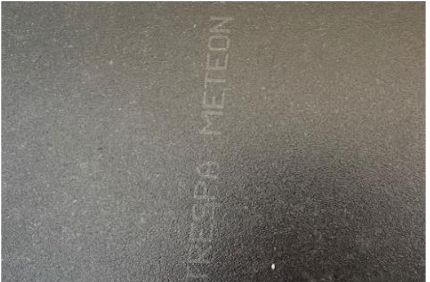
Material type	Trespa Meteon HPL panel

Material depth	8mm thick	
Comments	Euroclass B or lower

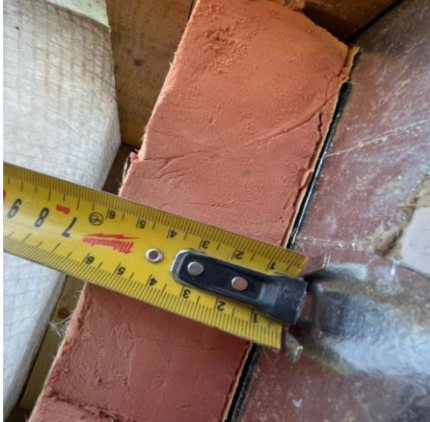
Material Type	Phenolic foam

Material depth	60mm	
Comments	Euroclass B or lower

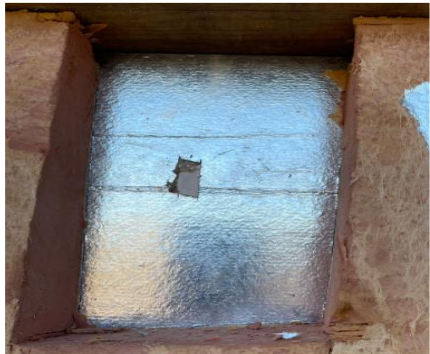
Material type	Timber framing with plasterboard

Material depth	Timber framing 100mm , plasterboard presumed minimum 12.5mm	
Comments	Timber framed backing walls are categorized as Euroclass B or lower. Further intrusive investigations un-warranted as this backs into living area

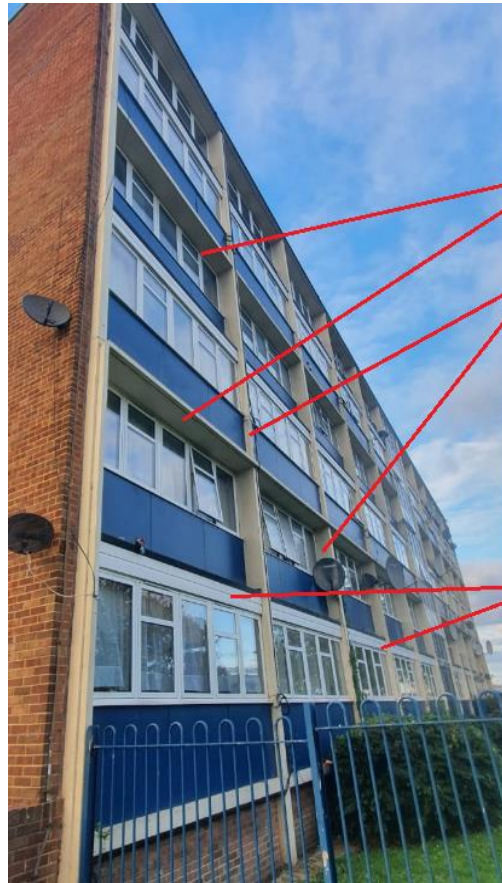
FIRE BARRIERS		
Horizontal	At floor levels the slab provides a nominal barrier between units.	(See diagram in the additional notes)
Vertical	To the rear elevation the UPVC cladding (on timber framework) between the individual maisonette floor levels, is constructed of combustible materials which abutt and are flush to the outer surface of the vertical compartmentation party wall, with the same material detail of the next unit adjacent, this aspect should be considered as part of the overall Fire Risk Assessment of the building.	(See anotated photo's in the Observations section)
Penetrations	N/A

Floor slabs provide horizontal (nominal) fire barrier

Vertical masonry party walls provide (nominal) fire barrier

Upvc/Grp / felt on timber framework

Should the client wish to remove combustible materials; design development and options appraisals will be required to address the front and rear elevations in respect of:

- Trespa Metoen HPL Panels,
- Phenolic foam insulation,
- Timber subframe,
- UPVC / GRP trims,
- Infill panels on communal windows.
